P-15210 Bridge, 116 Highway, Québec

During the rehabilitation of the P-15210 Bridge, which straddles Highway 116, north of Highway 30 in Québec, Construction Concrete Ltd. retained GKM Consultants to monitor, in real-time, the concrete deck lifting operations.

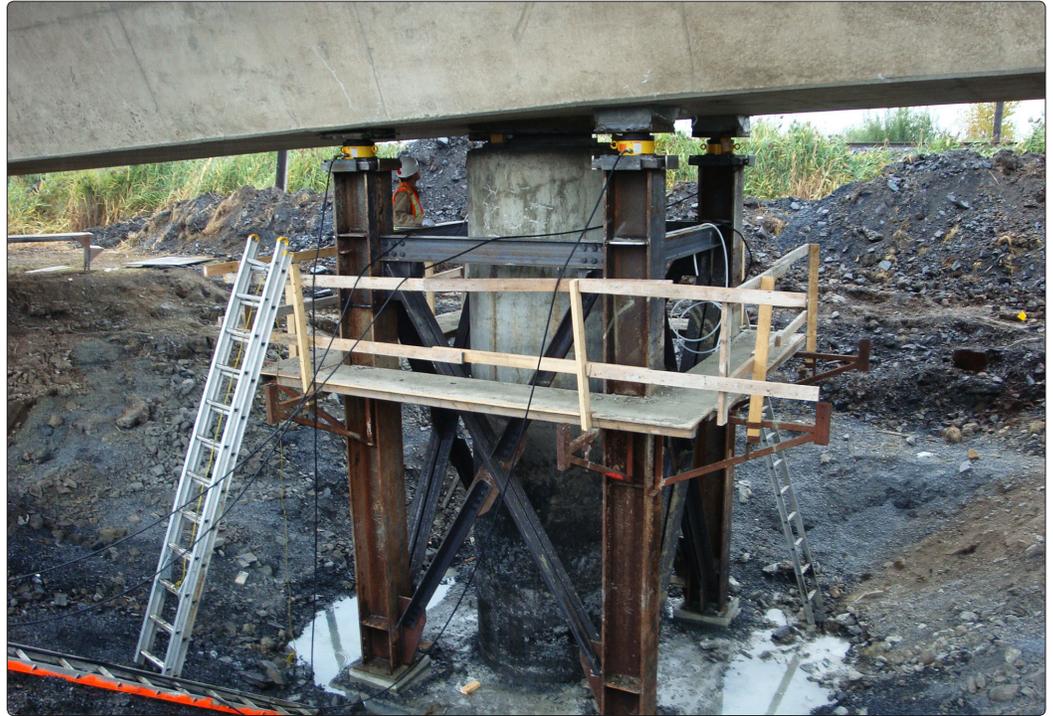
• Lifting support at Pile #2 for bearing device repair

To evaluate the strain variation due to thermal effect (without traffic) the bridge was monitored for several days, and, depending on the location of the sensors, the results revealed a deformation between $100 \mu\epsilon$ and $150 \mu\epsilon$ over a 10°C temperature range. Furthermore, only $10 \mu\epsilon$ were recorded at abutment for a 5mm deck hosting allowing complete unload and repair of bearing devices.
