Geotechnical and structural monitoring system deployment for the spillway of a dam at Padcal mine in the Philippines

V. Le Borgne, A. Cosentino, S.-É. Thivierge & J.-M. Br  h  
GKM Consultants, Sainte-Julie, Qu  bec, Canada

The Padcal Mine in the Philippines has been in service for over 50 years. To complete the most recent life-extension projects of the mine, the owner has been upgrading the most recently built tailing dam. It is a concrete gravity dam, the largest of its kind in a tailings facility in the world. To ensure long term reliability of the dam, a major instrumentation system has been installed to provide real-time structural data. Instruments include in-place inclinometers, joint meters across concrete blocks, piezometers within the dam and extensometers. In-place inclinometers were installed in the already-built concrete structure between the spillway and a gallery. Multipoint extensometers were installed through the existing structure into the soil underneath the dam. This being an already-existing dam under expansion, retrofitting the existing structure with new instruments was met significant hurdles. In this case study, we present the methods developed to tackle

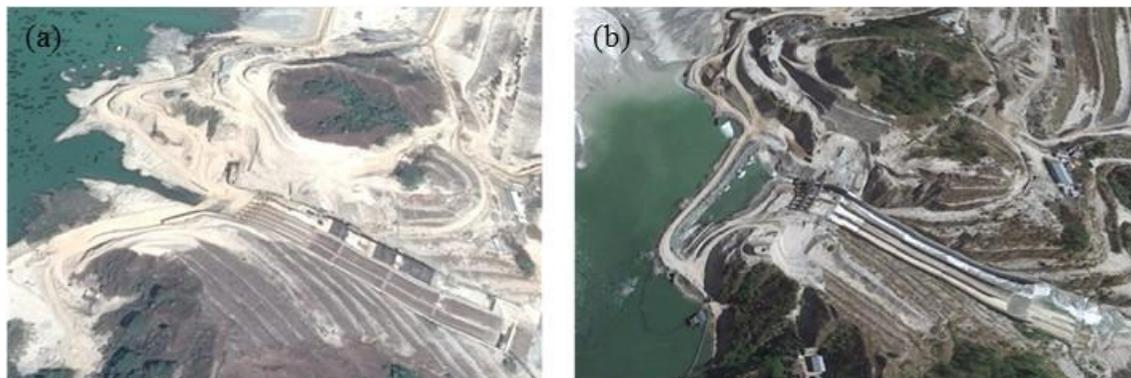
Figure 1 Padcal mine concrete dam. (a) The dam in early 2014. Two of the three spillways were completed. (b) The dam in 2018. The three spillways are seen, with water overflow going down spillway 3.

The challenges of maintaining a large tailings system of this type in this landscape was abruptly brought to public attention in 2012. The mine was faced with significant challenges when an acid waste drainage tunnel under penstock 3 ruptured (Catholic Bishops Conference of the Philippines 2012). The mine operator claims that this was a "force majeure" event caused by heavier than usual rainfalls (Caluza 2013). An estimated 20 million metric ton of tailings escaped through punctured roof of the tunnel (Dinglasaz 2013). The leak led to a significant increase in heavy metals levels downstream and ecological damage to the creek (Dinglasaz 2013). It also damaged one of the offset dikes of the tailings, lowering its capacity for future operations. The leak was plugged with a large concrete boulder that gave sufficient time for the team to backfill the tunnel. Because this section of the tailings was compromised, there was an increased risk of further failures due to damage to the existing dams. To limit the risks that future heavy rainfalls could pose, a new concrete gravity dam with three 12-meter spillways was designed and built (Dinglasaz 2013). As of 2014, the first sections of the dams and a first spillway was put in service, designed to accommodate up to 1500 mm of rain. A satellite image of the dam in 2014 before the opening of the first spillways is shown in Figure 1 (a). Over the following years, two more spillways were built and the top of the dam was raised, as shown in Figure 1 (b).

A satellite image of the dam (google) from 2018 is shown in Figure 1 (b). It can be seen that, as of 2018, the three spillways are built, and that water is flowing in spillway 3.

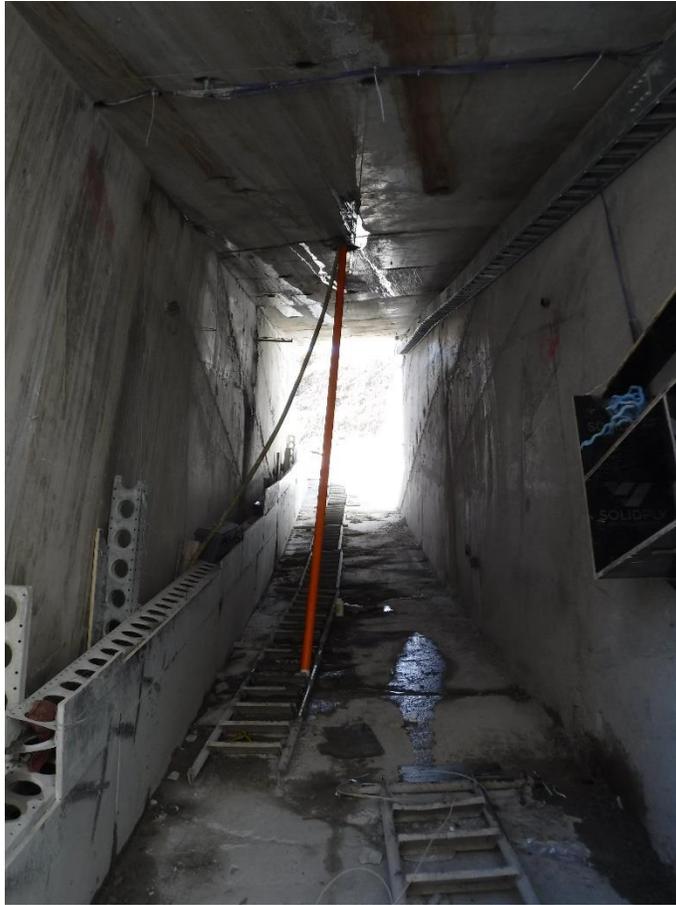
Figure 2 View from inside the gallery where inclinometer casing is being installed. The casing is slid through the roof of the gallery after which a worker will go and insert in the borehole in the floor of the gallery.

In this project, the casing had to be inserted from the top of the dam, down into the gallery, where another worker would align the casing inside the borehole for final installation. This was the only way to accommodate the 3m casing length. This operation is illustrated in Figure 2.

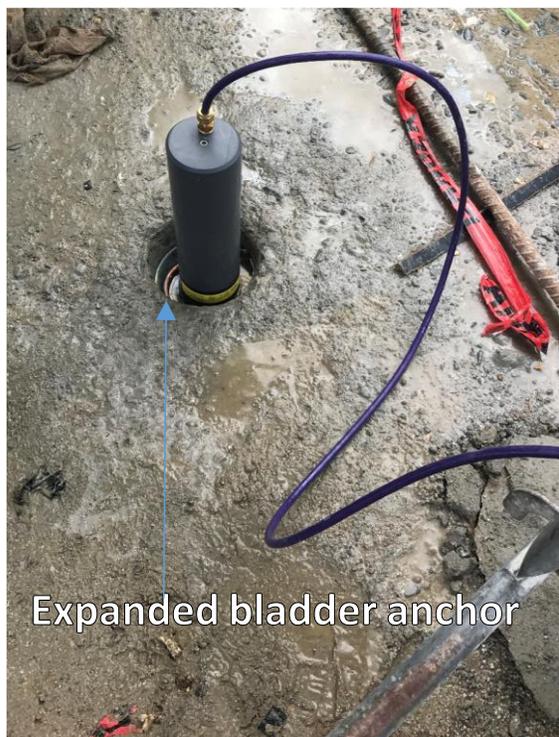
Figure 5 (a) MPBX head sticking out from the floor of the gallery (b) MPBX head after being encased in concrete

Figure 5 shows the final installation of an MPBX head before it is encased fully in concrete. Because the MPBX was to be installed directly in the boreholes without casing, bladder type anchors for the rods were used. These anchors provide direct contact with soil and/or rock and preclude the need for grouting. The system is designed in such a way that each anchor can be inflated sequentially to anchor locally each rod. In addition using bladder anchors, the MPBX were grouted in place to limit water circulation along the inside of the boreholes. The bladder anchors were inflated only after the grout had set. This double approach ensures the most reliable

long term measurements with anchors stronger than simple groutable anchors and the benefits of a watertight grout-filled borehole.

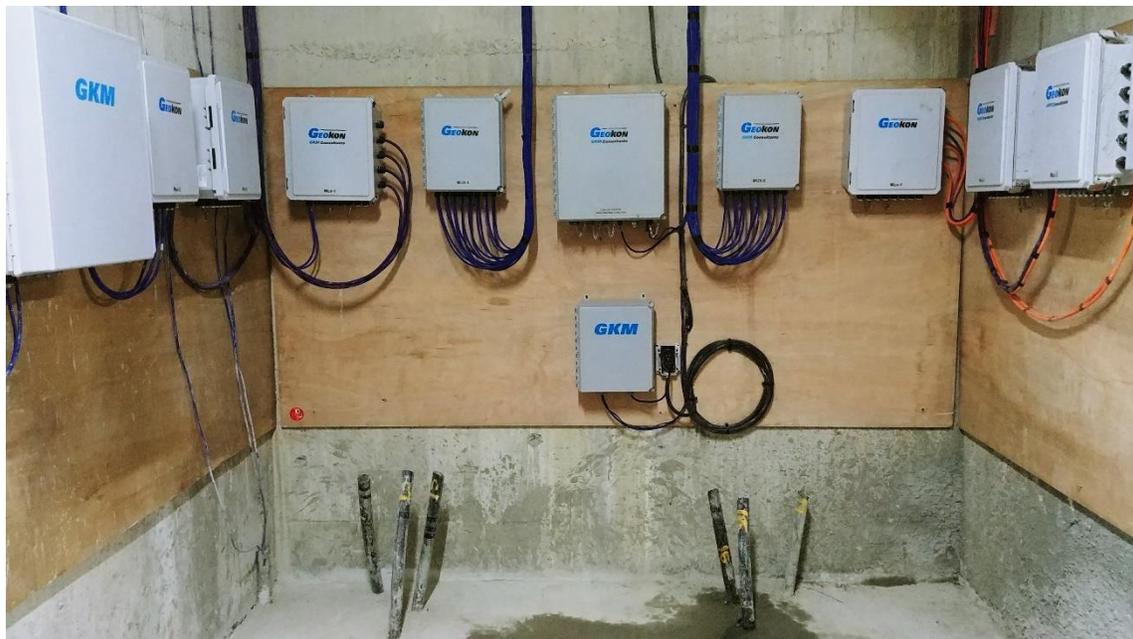
Figure 7 Data logging system where all instruments are connected

The data logging system was fully centralized as shown in Figure 7. All multiplexers and data loggers are located in a single room. This approach increases the manpower requirements for and cost of cabling itself, but it's a troubleshooting is greatly simplified when working from a single location.
